## TECHNICAL SERVICE BULLETIN

### Clicking/Scraping Noise From Under The Vehicle When Moving With Heat Shield Detachment

**21-2296**

Ford  
2021 F-150

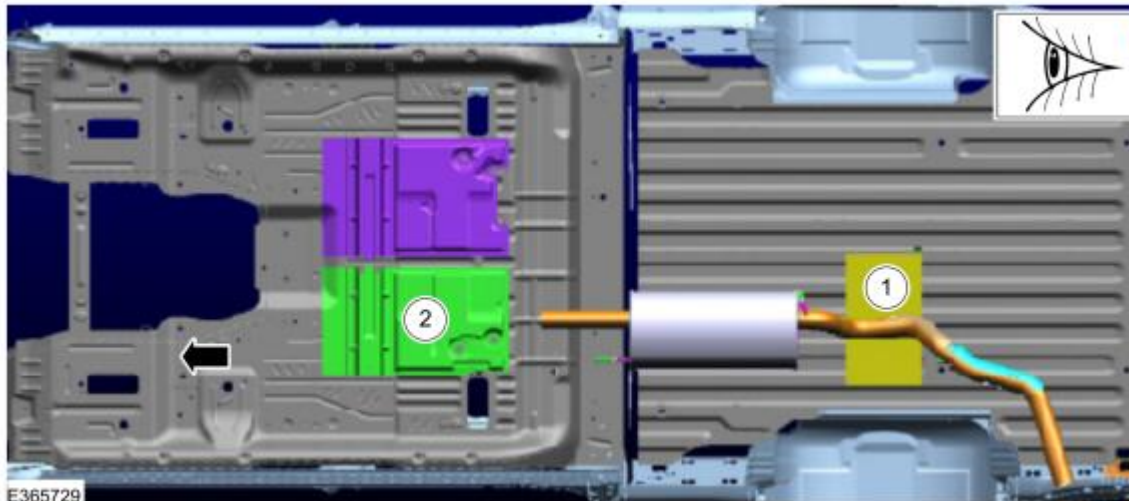
1. Position the vehicle on a hoist. Refer to Workshop Manual (WSM), Section 100-02.
2. Inspect the underside of the vehicle for a detached and/or missing heat shield in the locations shown in Figure 1. The corners of the heat shields being inspected should be firmly secured. Is there a detached and/or missing heat shield from the underside of the pickup bed (Figure 1 Callout 1) and/or the underside of the body (Figure 1 Callout 2)?

Item	Description
1	Heat shield location 1, underside of the pickup bed
2	Heat shield location 2, underside of the body

(1). Yes - for a detached or missing heat shield from the underside of the pickup bed (Figure 1 Callout 1) or both locations in Figure 1, proceed to Step 3. For only a detached heat shield from the underside of the body (Figure 1 Callout 2), proceed to Step 4.

3. Replace the heat shield on the underside of the pickup bed (Figure 1 Callout 1).

(4). For vehicles with no detached and/or missing heat shield at the location shown in Figure 1 Callout 2, repair is complete. For vehicles with a detached and/or missing heat shield at the location shown in Figure 1 Callout 2, proceed to Step 4.

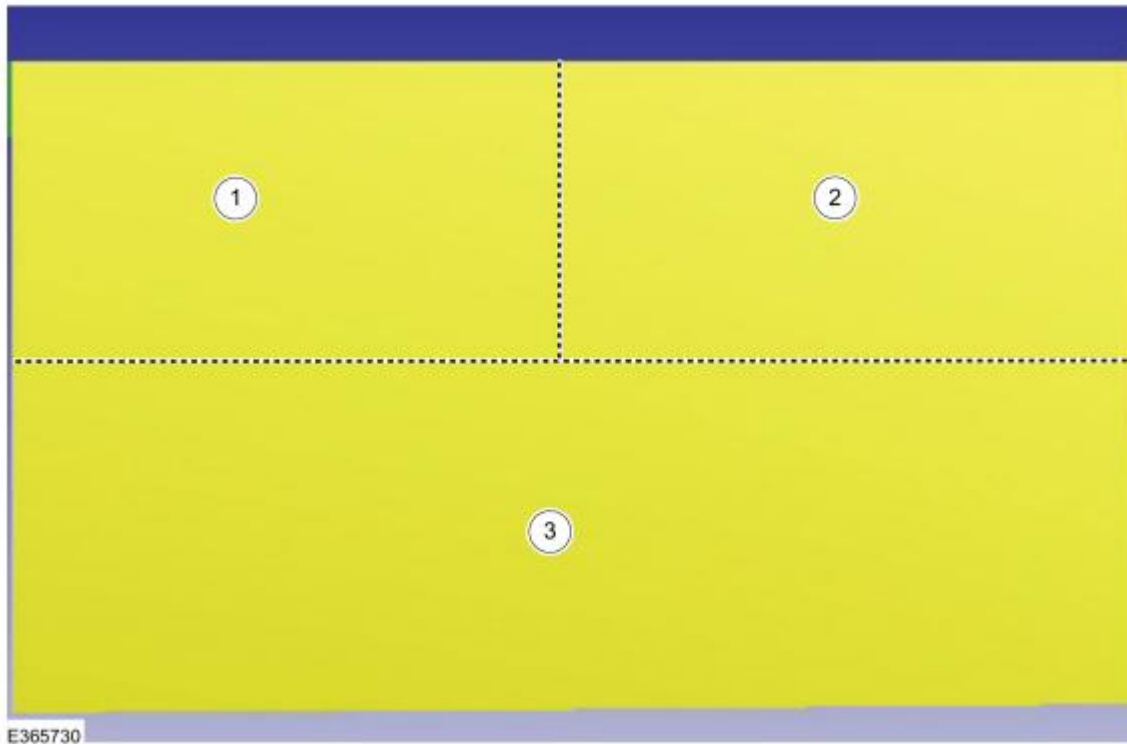
Figure 2

Item	Description
1	150 mm x 260 mm
2	150 mm x 260 mm
3	150 mm x 520 mm

(1). Create 2 small individual repair patch sections by cutting a heat shield as shown in Figure 2. The 2 smaller pieces are to be cut 150mm x 260mm.

(1). Create 3 smaller individual repair patch sections by cutting a heat shield as shown in Figure 2. One long piece is to be cut 150mm x 520mm, and 2 smaller pieces are to be cut 150mm x 260mm.

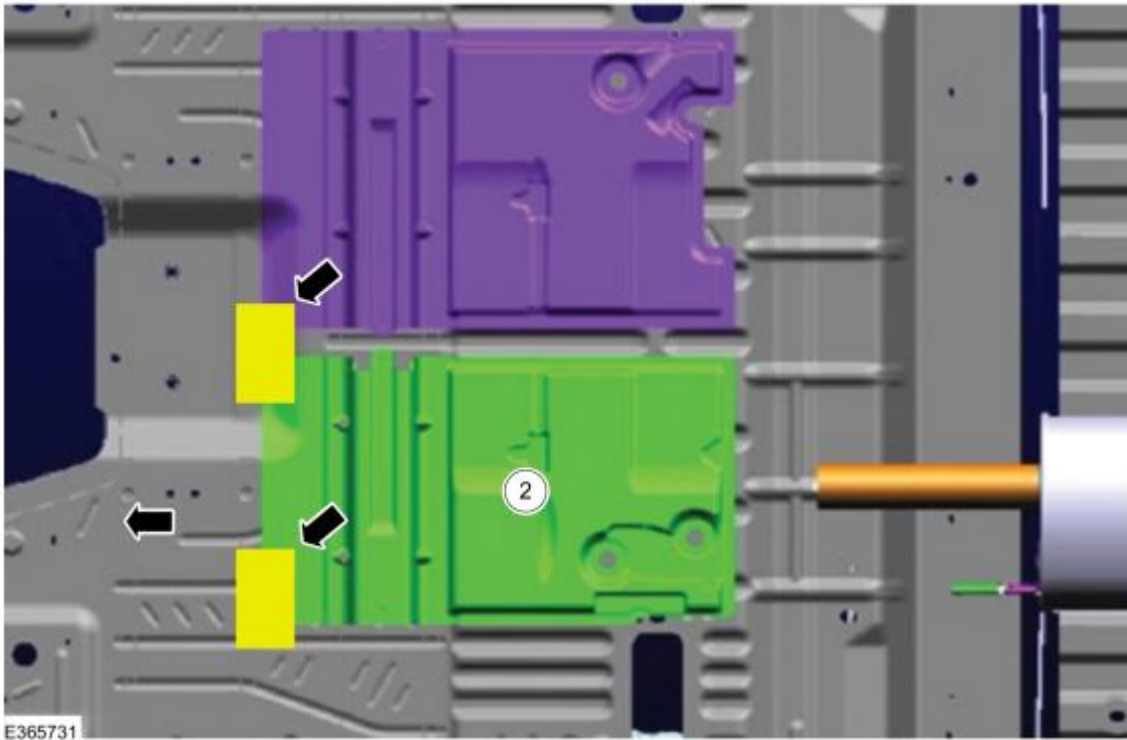
Figure 3

**NOTE: If the front corner of the original heat shield has sustained some minor damage as a result of coming in contact with the driveshaft, the damaged section can be trimmed away. The repair patch being installed will provide heat shielding protection for the section that was trimmed away.**

(3). Remove the protective liners from the back of the repair patch sections to expose the adhesive. Apply the repair patch sections in only the 2 areas indicated in Figure 3. Firmly push the heat shield against all the sheet metal and the factory installed heat shield surfaces that the repair patch sections come in contact with. This will make sure there is proper adhesion to all surfaces. Some overlap of the repair patch onto the driver side heat shield is expected and acceptable.

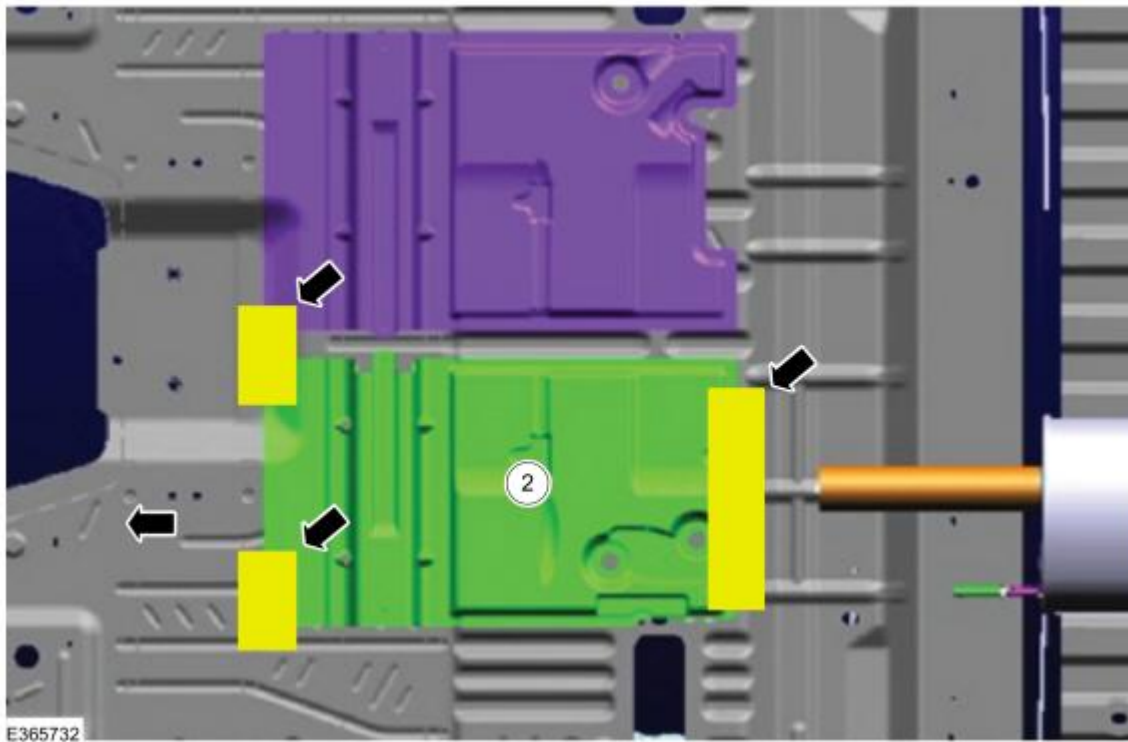
Figure 4

**NOTE: If the front corner of the original heat shield has sustained some minor damage as a result of coming in contact with the driveshaft, the damaged section can be trimmed away. The repair patch being installed will provide heat shielding protection for the section that was trimmed away.**

(3). Remove the protective liners from the back of the repair patch sections to expose the adhesive. Apply the repair patch sections in the 3 areas indicated in Figure 4. Firmly push the heat shield against all the sheet metal and the factory installed heat shield surfaces that the repair patch sections come in contact with. This will make sure there is proper adhesion to all surfaces. Some overlap of the repair patch onto the driver side heat shield is expected and acceptable.
